REPORT ON TWO WATER SYSTEMS
ALPINE VISITOR CENTER
WILD BASIN PICNIC GROUND
ROCKY MOUNTAIN NATIONAL PARK

DENVER SERVICE CENTER
NATIONAL PARK SERVICE

CONTRACT NO. CX-2000-3-0021

20 January, 1984

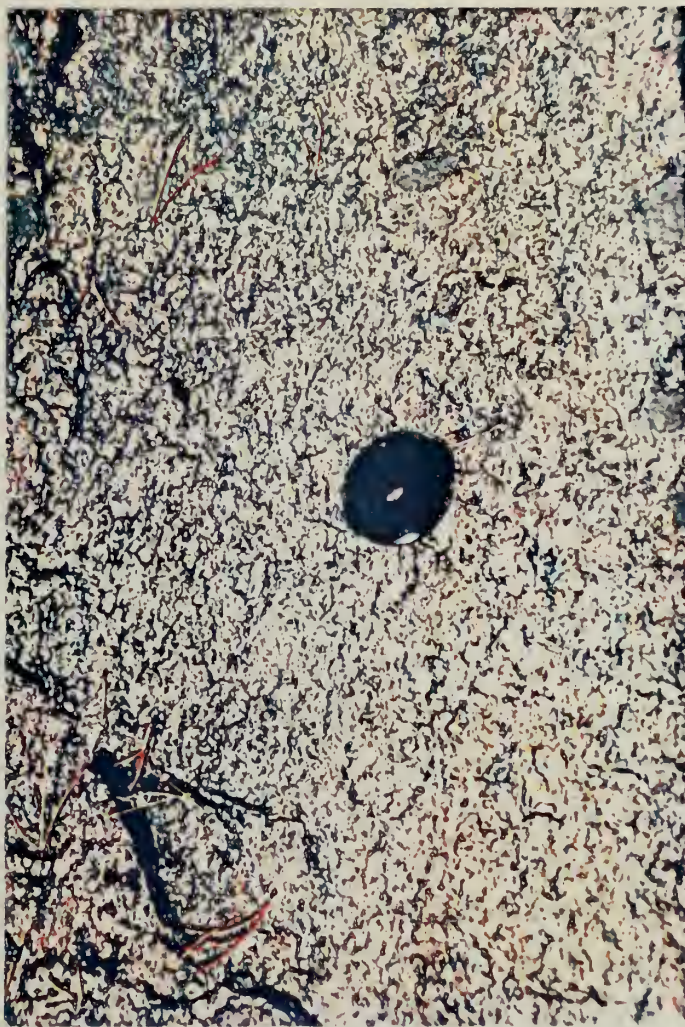
Photo No. 1 - Unweathered Silver Plume Granite

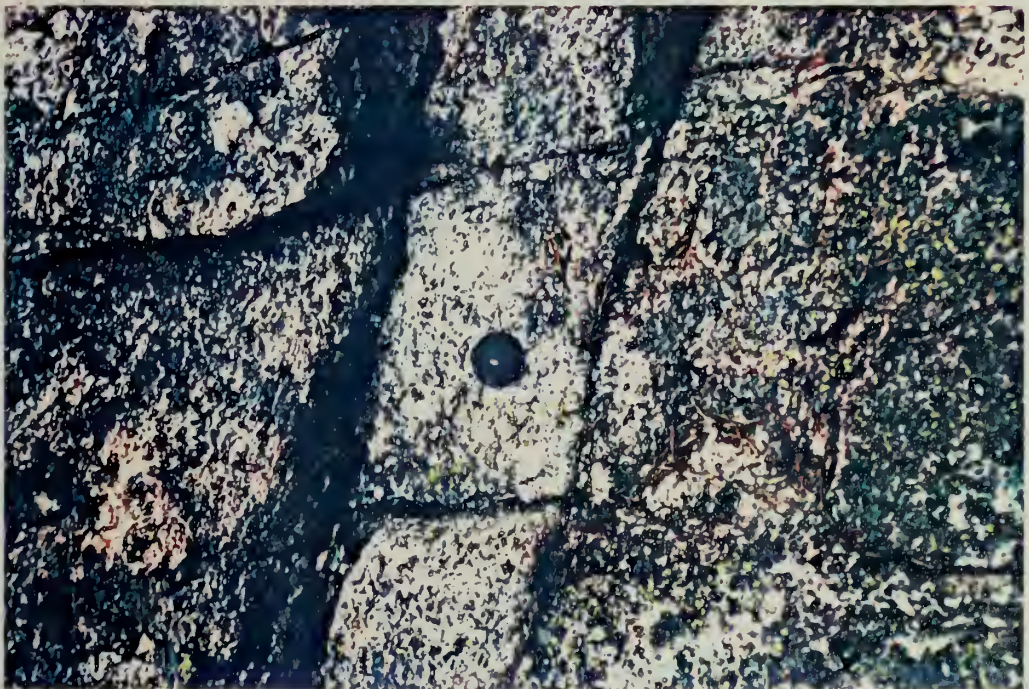
Photo No. 2 - Joints in the Silver Plume Granite

In the vicinity of the Wild Basin picnic ground, the basement crystalline rocks belong to the Silver Plume granite (Fig 2). The granite forms the valley walls along North St. Vrain and also outcrops at Copeland Falls, about 1,200 ft. upstream from the Ranger Station. This is "a pinkish gray, medium-grained slightly porphyritic biotite granite composed chiefly of pink and gray feldspars, smoky quartz, and biotite, but muscovite is present in some facies, and the percentage of biotite varies from place to place." (Lovering and Goddard, 1950) It is of late precambrian age that was intruded along faults and cross fractures in schist and gneiss. As seen in Photo No. 1, the faint orientation of the biotite (due most likely to flow banding) gives the granite a gneissose texture. It is faulted and jointed. As in other igneous bodies the joint systems in the Silver Plume granite are shrinkage joints developed as a result of cooling. The outcrop at Copeland Falls shows a joint system with two sets of intersecting joints striking 040° and 140° and dipping steeply (Photo No. 2). The surface opening on these joints due to

weathering can be as much as 3 inches. Horizontal or sub-horizontal joints also exist from erosional unloading.

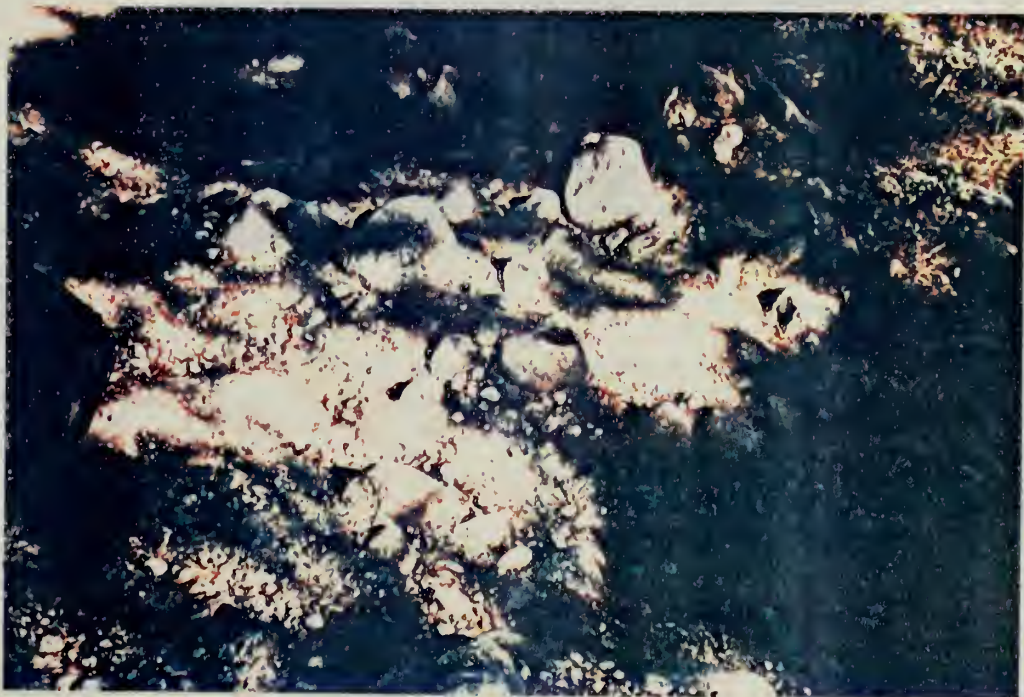
Photo No. 4 - Rounded boulders in the till deposit

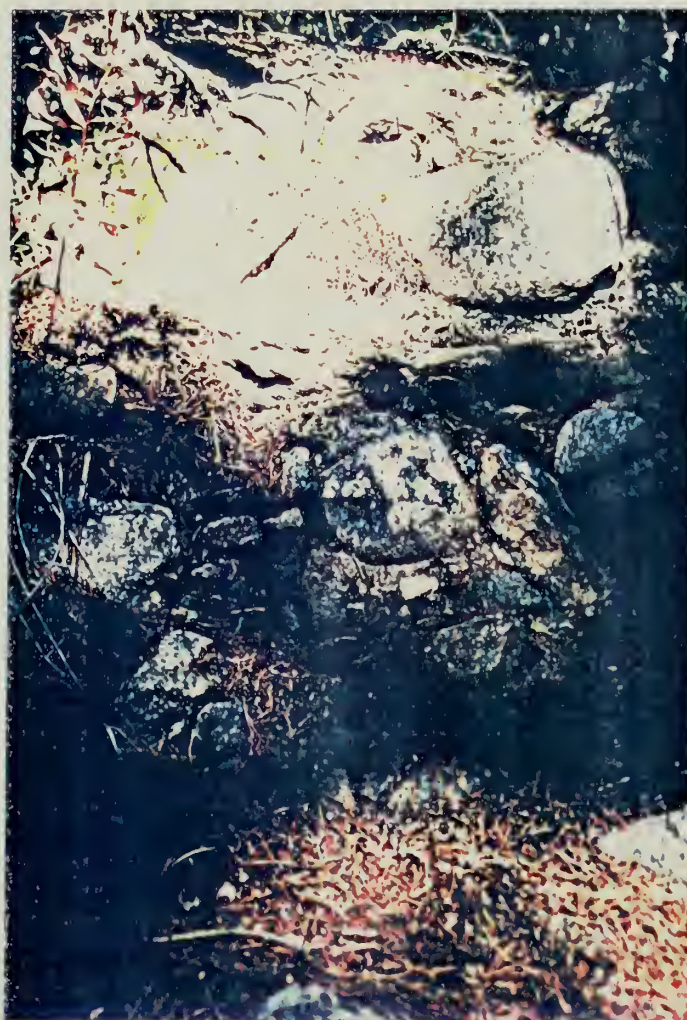
Photo No. 5 - Angular to sub-rounded boulders in the till deposit.

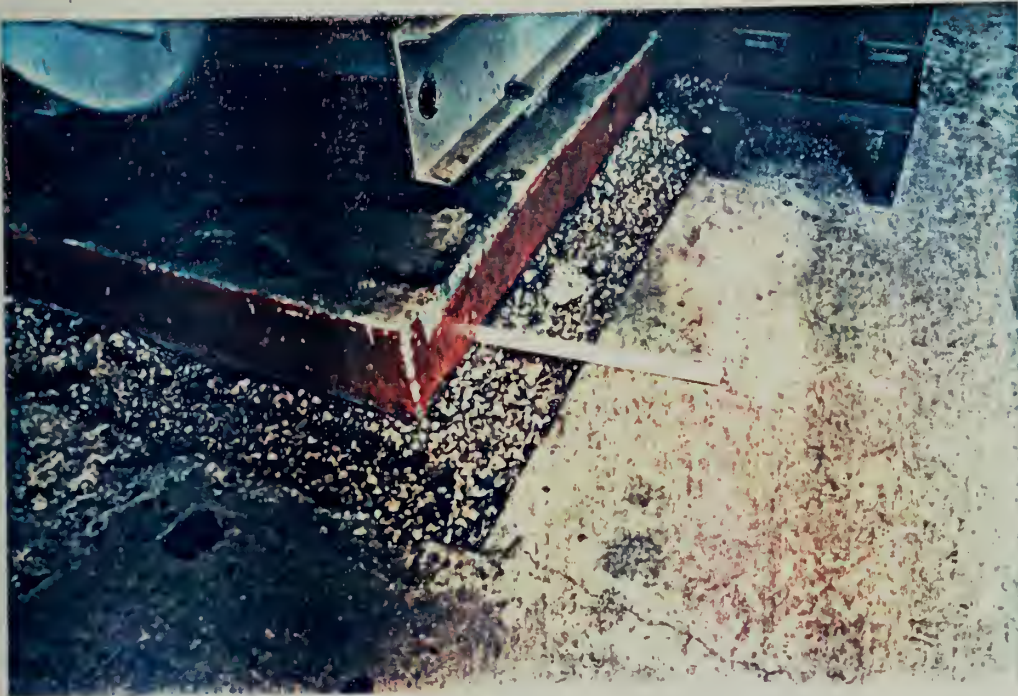
SAND BED FOR
VIBRATION ISOLATION
